# Service Bulletin

No 14 rev 3 2008-04-08

## Non return valves for protection of air distributor CD Units.

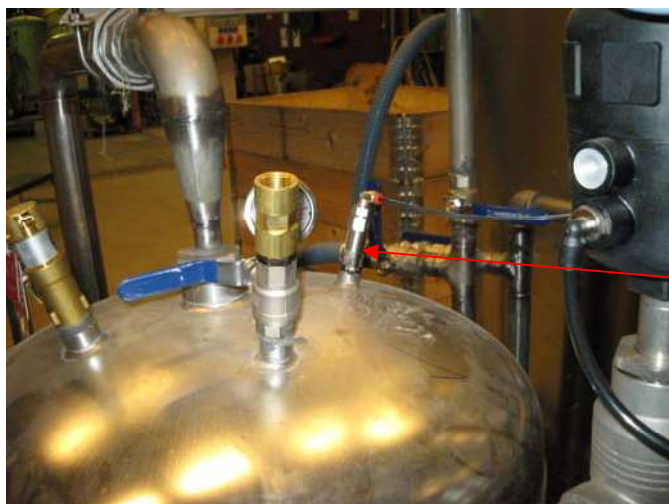
Non return valve #137  
16101

We have experienced damaged to the air distributor in the electric cabinet caused by water penetration on some vessels. This has been caused by leakage of the non return valve #137 on the circulation tank #52. See picture below:

In order to avoid and correct this problem Marinfloc recommend that the non-return valve is checked for leakage and replaced if necessary. Marinfloc also recommend that an extra non return valve is added to the hose after the air adjustment valve #136 for extra safety. See picture below:
